Batteries & Energy Storage Technology

No. 59  
Winter 2018

## How bad formation connections cost you

# Bad connections make your losses grow

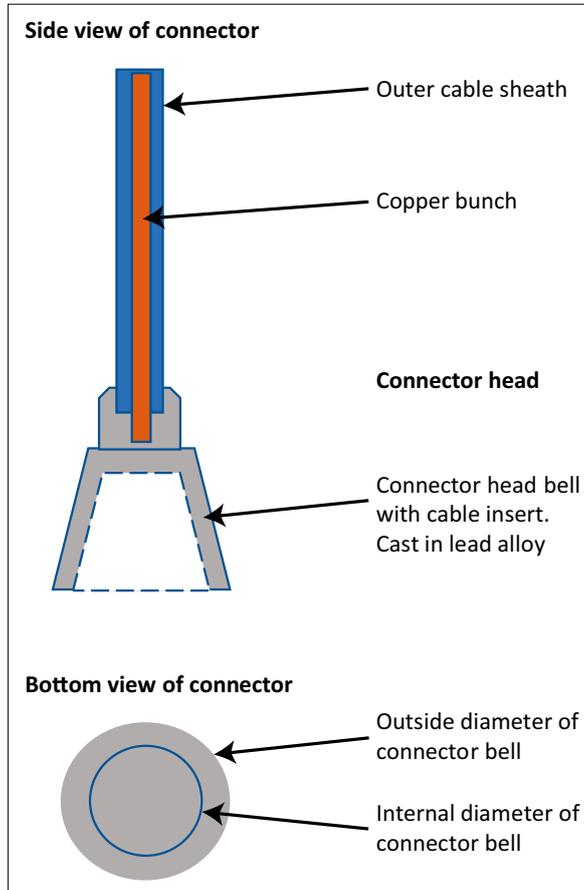
*Fig 1: Schematic of standard connector*

**Fig 1** is a schematic view of a typical formation connector showing the materials of construction and fabrication methods. The lead terminal is connected to the insulated copper wire when it is cast in a mould. The end of the bared cable is usually dipped in a flux and lead tin solder to ensure the wettability of the cable when the molten lead alloy is poured into the mould. Lead is the normal choice for the terminal as it is both electrically conductive and resistant to sulfuric acid.

There are potential areas for corrosion with this design due to either acid ingress at poor joints or spillage onto the terminal from the connection and formation process. Other types of contamination are also possible due to oil in the battery electrolyte or charred plastic from burnt lids. A poorly conductive surface from any

The standard design of connector has been described earlier and has several shortcomings.

- The cable to connector head joint is prone to acid ingress due to cracks opening up with repeated stress from the handling methods used by formation operators. The connector-cable end and lead end material are prone to

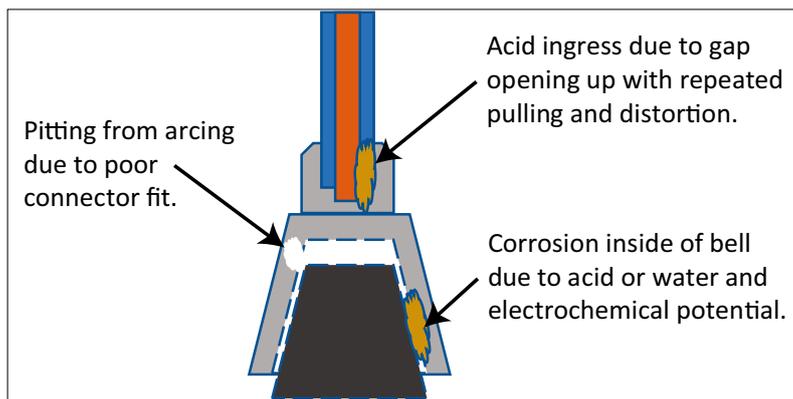
*Fig 2: Standard design connector fitting over a battery terminal post. Corrosion and damage zones*

possible source will increase the resistance of the joint between the connector and the battery terminal post. The resistance is caused by a non- or partially-conducting layer over the interior surface of the connector terminal. **Fig 2** shows how the build-up of this layer will affect the connector/post interface to increase the resistance.

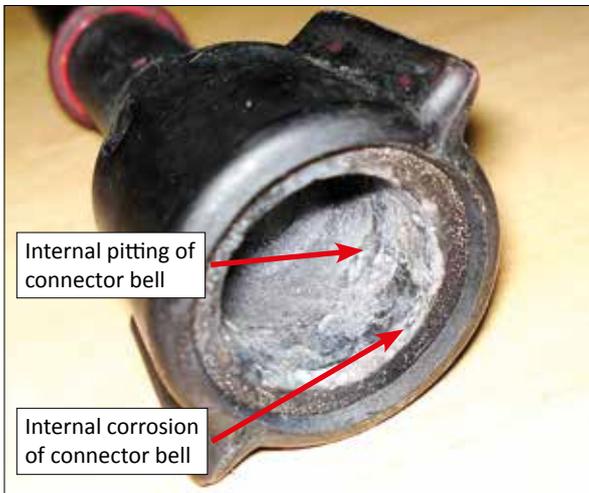
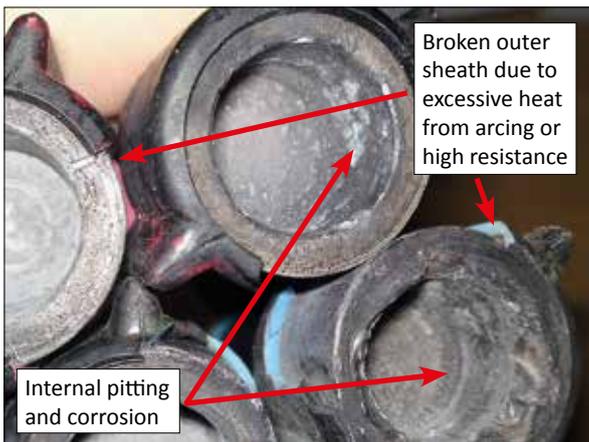
Fig 3: Used connectors in service  
3a (above): Typical connector condition with several months use  
3b (below): Connectors with heat damaged outer casings

Another source of connector high resistance, apart from corrosion, is the physical damage to the terminal, either by distortion or gouging of the interior to produce bumps or deep rivulets into the surface, providing sites for electrical arcing. This problem can cause serious damage to the battery terminal and lid as well as to the connector, leading to either scrapping or reworking of the battery. The poor condition that connectors can reach in service is shown in **Figs 3a** and **3b**, which show both pitting and internal corrosion.

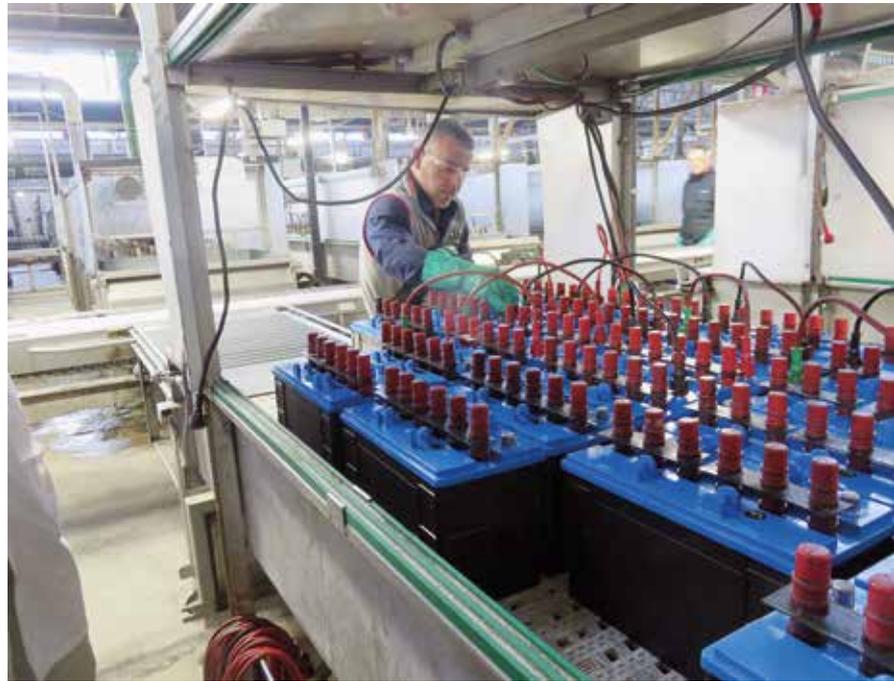
Figure 4: Typical water bath and formation circuit for monobloc batteries

In the majority of lead-acid battery formation departments, there is limited time to fix the intercell connectors to the battery posts. The majority of monobloc processes have moving conveyors feeding batteries into the formation baths; many of these are not single line but may have three or four parallel rows of batteries. The operator has to reach all of the rows from a fixed position, normally leaning across the water bath, which may be more than a metre wide. (**Fig. 4**)

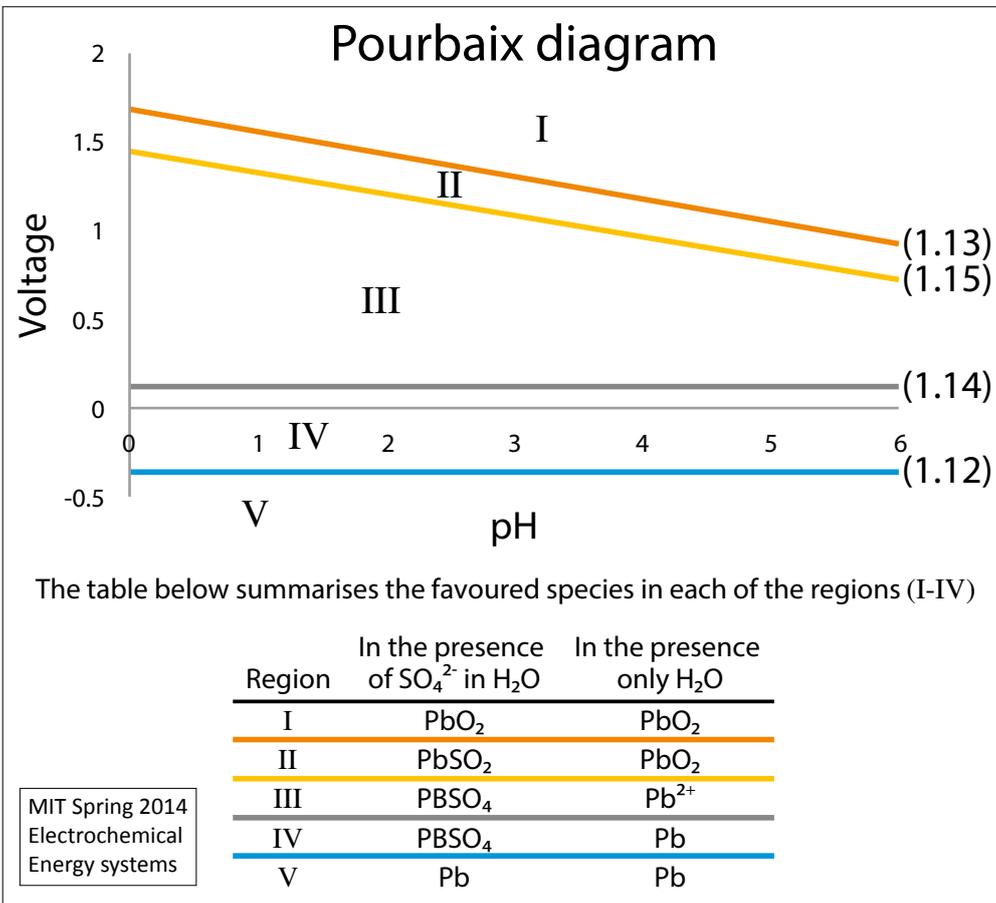
compounds formed we can look at the results obtained from connector/battery terminal resistance tests and the typical environmental conditions experienced by formation connectors. Reference to the Pourbaix diagram for lead in sulfuric acid (Fig 5) shows clearly the potential and pH regions where lead forms lead sulfate. It is evident that at pH levels between 0 and 6 and potential

levels of -0.2 to +1.3 that lead is oxidised to  $Pb^{2+}$  and will form lead sulfate according to the reaction:

Fig 5: Derived Pourbaix diagram showing fields of corrosion and stability for lead in sulfuric acid and water. MIT Spring 2014 Electrochemical Energy systems
