Batteries & Energy Storage Technology **No. 66**
Autumn 2019

Resistance is futile

(With a nod to the Borg from Star Trek) Dr Mike McDonagh summarises two years of laboratory testing that shows the importance of connectors, and their maintenance, for lead-acid battery formation and how they can lower resistance during battery formation to save your company from serious financial losses.

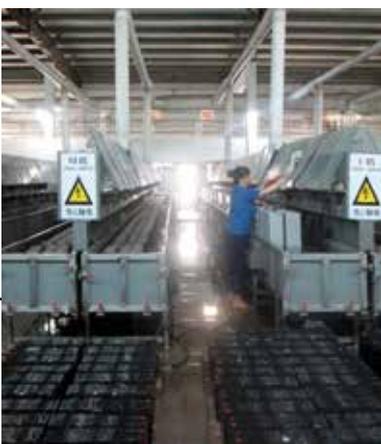
Fig 1 (left): Lead-acid battery formation department

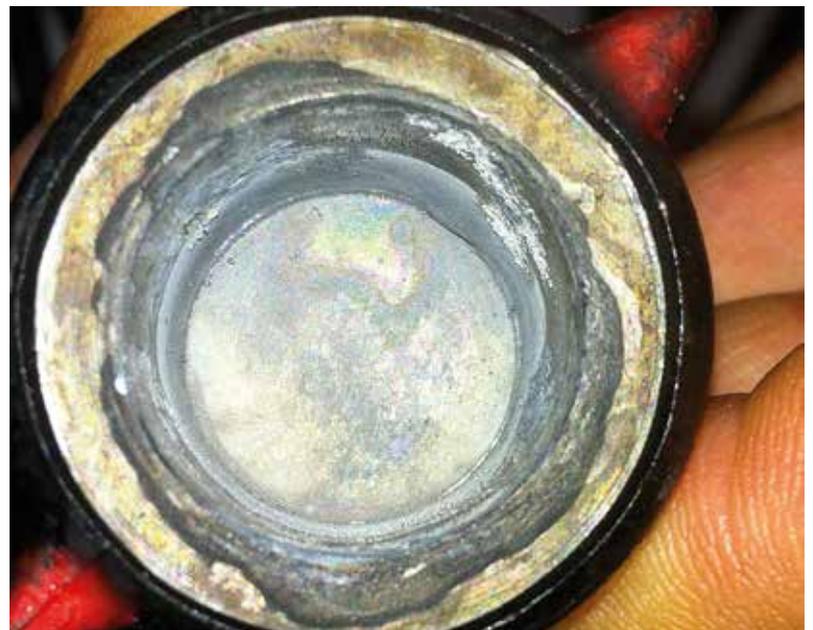
Fig 2 (right): Typical level of connector corrosion in a battery formation department

some assessments of the impact of this on the integrity of the product and the financial and throughput implications for most lead-acid battery factories. Over almost two years the study has identified a unique corrosion layer to be the cause of the high resistance, it is formed as a result of process, environment, working practices and connector design on the inside of the connector lead terminals (**Fig 2**).

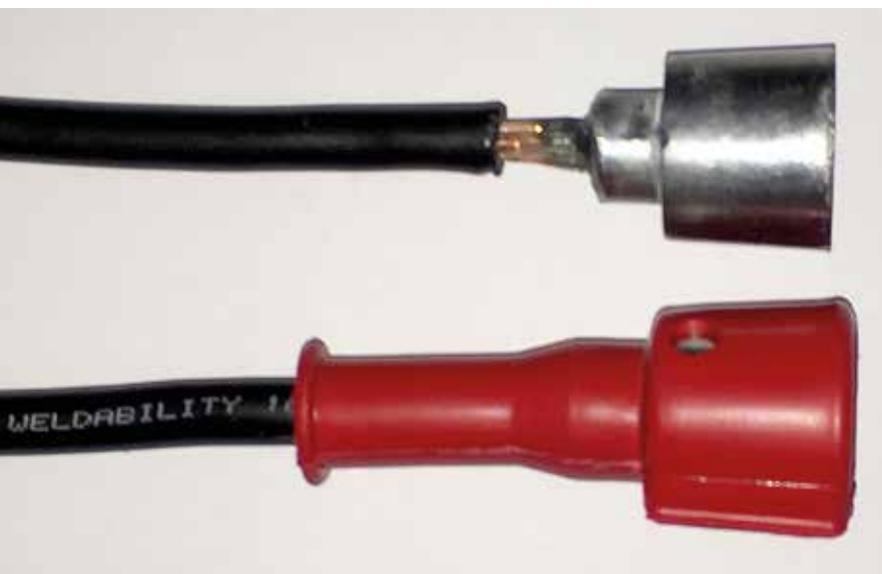
Fig 3: Standard lead alloy formation connector

Because of innovations in battery cooling methods, which include electrolyte circulation equipment, battery temperatures during formation, which are the usual limitation for current input during the process, could be kept to the same low values, even with higher formation currents. Over several years of gradual improvement, manufacturers have been able to reduce formation times to half, or even less, than they were a decade ago. Whilst this sounds like good news it was Rigby who noted that although the processes of current input and battery cooling were greatly improved, the connector construction and design have remained unchanged for more than 20 years **Fig 3**.

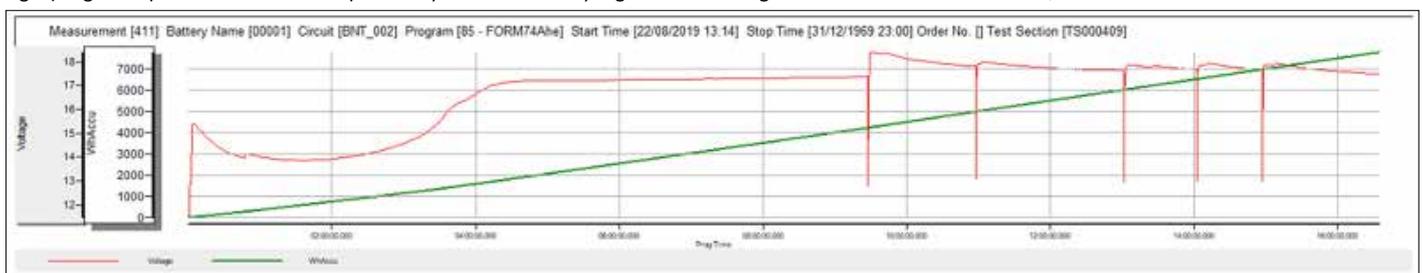
Fig 14: Digatron formation test results from temperature limited programme— voltage and accumulated watt hours, used connectors

Figs 13 and 14 show the results from the Digatron test unit for the green batteries formed using the supplied programme. **Fig 13** gives the results for formation using new connectors and **Fig 14** is for formation with used connectors. In both cases the programme was temperature limited. This means that when the battery temperature exceeded the set value, in this case 68°C, the current would be reduced or switched off completely until the cell temperature dropped to 65°C. It would then switch back to the full fixed current value of the programme.

From the Digatron graphs it can be seen that the programme was interrupted more often for the used connectors than for the new connectors. In total the extra time for the programme to complete for the used connectors was an additional 1.8 hours compared to the battery formed using the new

connectors. The programme is designed to take 24 hours but in this case was prolonged by nearly 8%. This represents a loss of throughput close to 80,000 batteries per one million processed annually. In monetary terms it amounts to an income loss of around \$1.6 million per annum for every one million batteries produced. For a five million batteries per annum facility, this would give a staggering \$8 million per annum revenue loss.

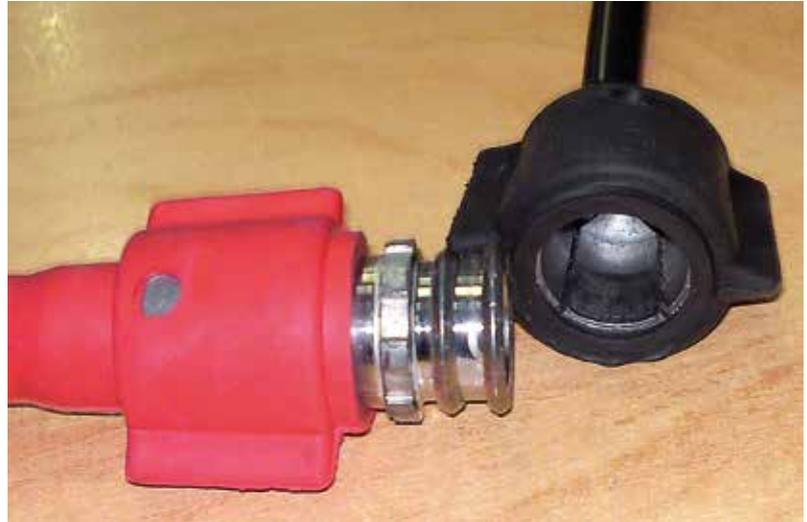
Fig 16: New UK Powertech connectors

Fig 16 shows the new connector designs from UK Powertech, which are easier to fit due to the split lead alloy head, and also prevent acid ingress to the connector's internal surface. However, current connector designs in use by most companies would benefit from small but effective maintenance procedures such as regular washing and storage in dry conditions rather than leaving them in a plastic tub already badly contaminated with acid.
