Batteries & Energy Storage Technology

No. 64
Spring 2019

Connector corrosion under the microscope

UK Powertech and *BESTmag* get down and dirty with connector corrosion chemistry to find solutions to formation energy losses in lead batteries.

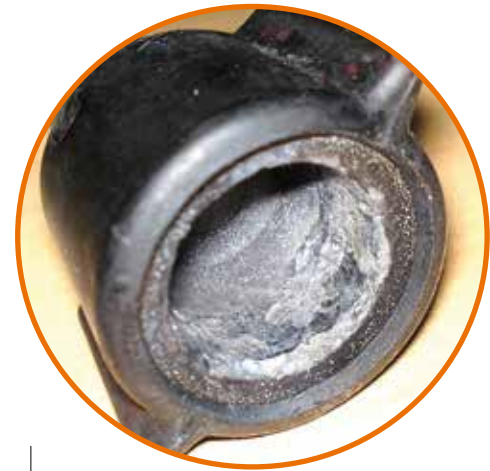
Fig 1: Camera pictures of the reference (a) and used (b) connectors, both ring and cone terminals.

In the first part (electrical test results) of this report, we compare the efficiency of new lead-acid battery formation connectors with those that have become corroded after a short time in service (**Fig 1**). A new, more user-friendly connector lead terminal design is also examined and compared with the existing design. The second part of the report examines the chemical nature of the corrosion layer and proposes reasons for its formation. The implications for the connector design, formation process modifications and potential damage to battery quality are discussed at the end of the report.

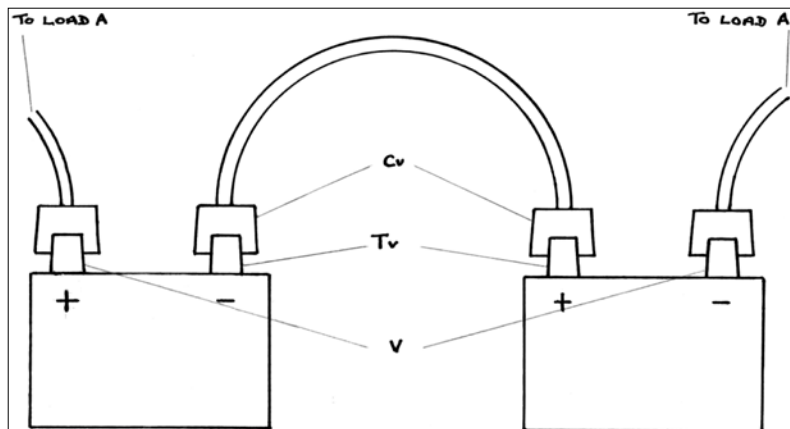
Fig 2: Method of measuring the connector/battery terminal interface resistance.

Tv = voltage measurement from battery terminal to terminal under load A amps
 Cv = voltage measurement from one connector end to other connector end under load A amps
 Tv-Cv = the voltage between the terminals and the connector ends under load A amps
 A = current flowing in the circuit.
 (Tv-Cv)/A = Connection resistance between battery terminals and connector ends

between good and corroded connectors was found to be an average of 7%. **Fig 2** shows the circuit arrangement for the initial single connector tests. The voltage across the positive and negative poles of two separate batteries in a series connection was measured with a 9A constant current. The voltage across the connectors was then measured at the same current. The voltage difference is created by the resistance drop across the connector terminal and battery post interface with a constant current flow. The higher the voltage the greater the resistance at the interface (Ohms law). The higher the resistance, the higher the voltage and therefore the higher the energy consumed in supplying the current ($V \times A \times t$).

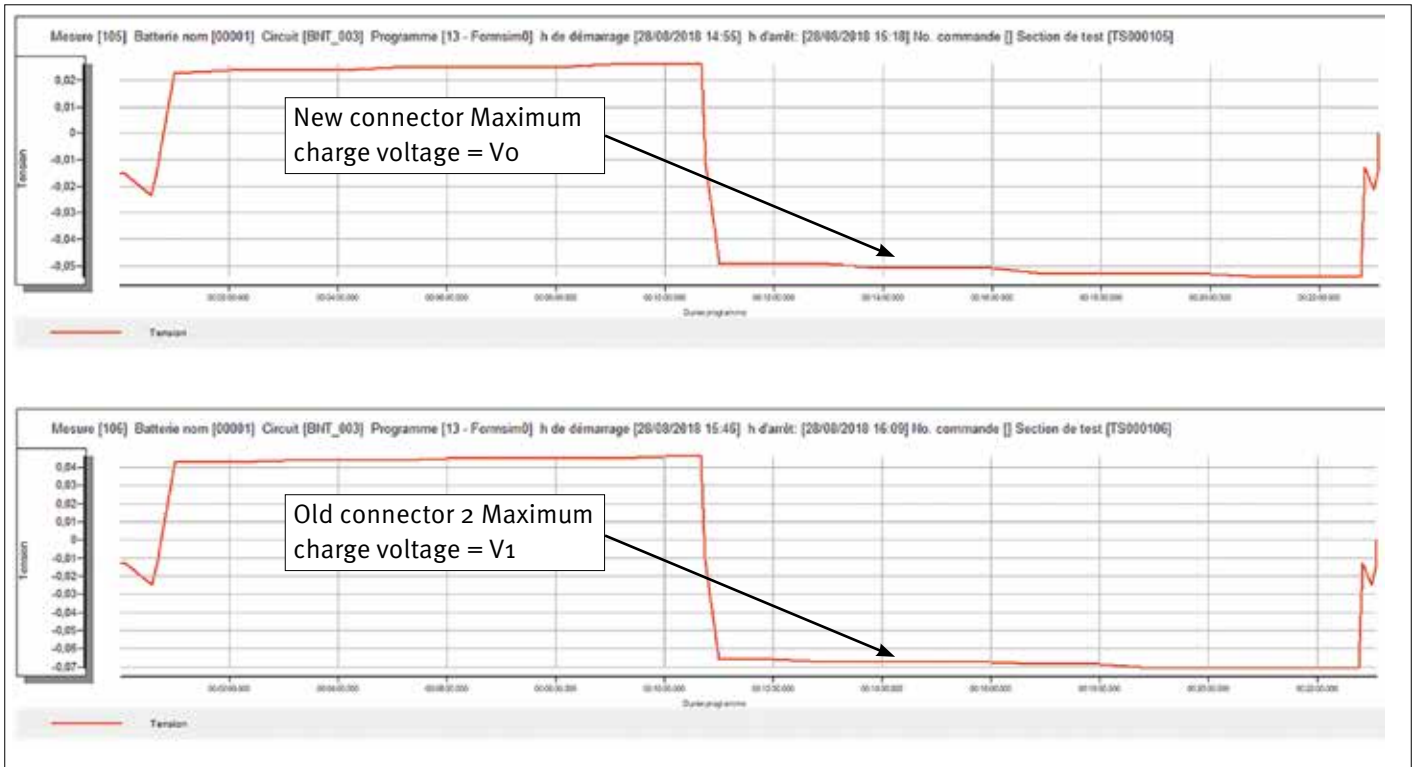
Fig 3: Typical results from the Digatron connector tests.

For verification of these results, further tests were carried out on the Digatron test unit. In these tests, batteries were put on charge with new and old connectors. The charge current was kept constant and the resulting voltage responses were measured for the different connectors. **Fig 3** shows the voltage responses at 25A for the old and new connectors. This is in line with the manual measurements taken from the test rig which provides verification for the results.

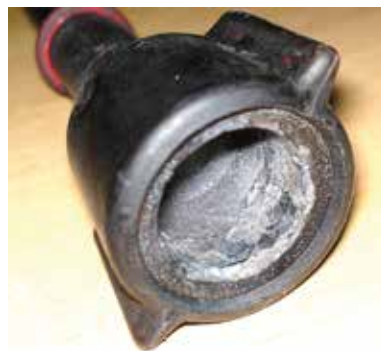
Fig 4: Used connector showing corroded and pitted internal contact surface.

The main purpose of this study was to ascertain the cause of the higher interface resistance when using the old connectors. **Fig 4** shows the internal condition of a used lead terminal connector. There is evidence of corrosion and pitting, which would be the obvious cause of the higher resistance, provided that the corrosion product was non, or partially conducting. It is necessary to ascertain the nature of the corrosion layer

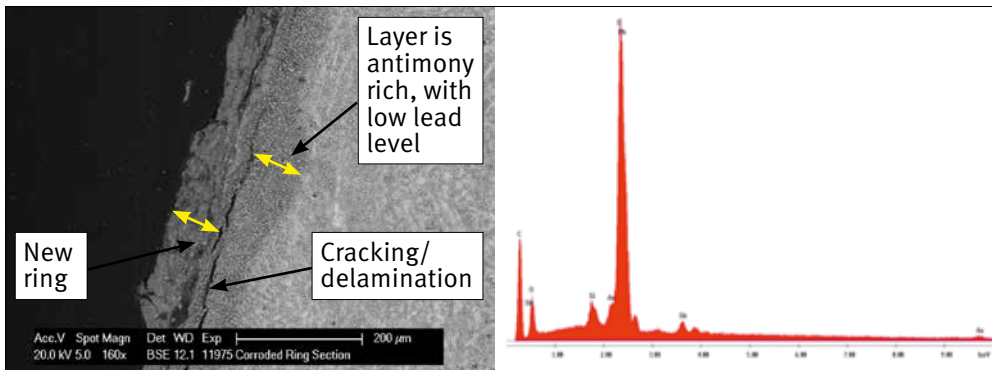
Fig 5: Cross section of the surface corrosion inside the connector terminal with an EDX reading of the elements in the corrosion layer.

Fig 5 shows extensive corrosion layers on the inside of the terminal ring, which are typically up to 160µm deep. The etchant used has delineated the bulk material from the outer delaminating corrosion deposit. It also indicates that the remaining bulk surface layer is richer in antimony and lower in lead than the bulk material.

The corrosion product is flaky and not well attached. The layer between the flaky part and

the substrate is antimony rich. This could form the basis of a conducting layer between the surface corrosion product and the lead substrate and would have a lower conductivity than the lead substrate due to the corrosion of lead. From the cross-sections, it appears that the depth of the corrosion level

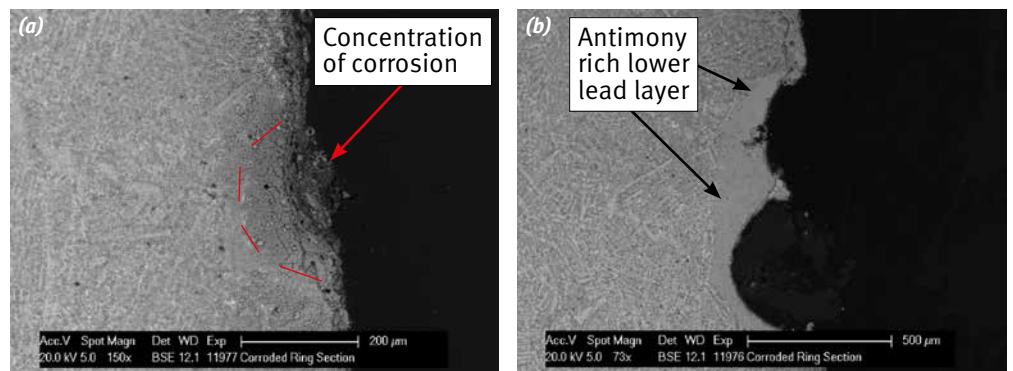
is around 160µm. The surface can be heavily pitted with corrosion. This would manifest itself as localised pitting as shown in Fig 6. In other words, the connector will still function but at a reduced efficiency with increasing pitting corrosion and pit depth. The cone surface also showed that there was localised melting of the terminal/cone, perhaps through localised arcing or high current density. This resulted in metal splatter being seen at the base of the cone in the form of spherical balls (Fig 7). This was also found within some of the corroded zone of the cone inner surface.

Fig 6: 6a is an SEM image of a corrosion pit. The corrosion is moving inward with a circular wave front. 6b is an image of a corrosion pit with the corrosion deposits crumbled away. The base is composed of an antimony rich and a lower lead layer.

In previous tests, this high resistance barrier layer combined with arc-pitting has already been shown to increase the energy required to form batteries by around 7% on average. Knowledge of the chemical composition and the mechanism of formation gained from this study has pointed to possible methods of reducing the extent of the corrosion and also methods of removing it. The crumbly but soft nature of the insulating outer layer means that mechanical removal would be best served by vibration rather than attrition methods. The samples used in these tests had an outer layer approximately 160 microns deep. However, removing this layer would not increase the internal diameter of the connectors by 320 microns (0.32 mm). The volume of the lead sulfate product is 164% greater than metallic lead, so the layer thickness removed would most likely result in an internal diameter increase of around 0.13mm. Considering the variables in most production environments, this should not cause any significant problems. Of more concern is the possibility of localised electrochemical action—causing the pitting seen in **Fig 6**— which could lead to some serious damage from arcing.

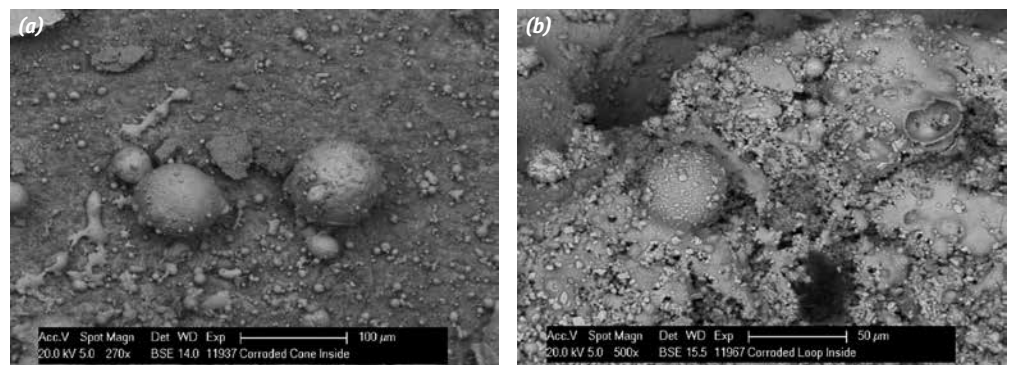
Fig 7: SEM picture of spherical nodules. 7a Balls resulting from arcing which create a point contact. 7b Melted metal forming spherical balls, some of them re-melted into the surface.

The main contributor to both areas was that of lead, sulfur and oxygen in the ratio range of 1:1:3-4. This suggests that the corrosion deposit is lead sulfate, but could be combinations of lead oxide, lead sulfide and lead sulfate. The surface of the spherical balls is mainly composed of lead, oxygen, antimony and sulfur. This represents molten alloy splatter, which likely has a film of lead sulfate on the surface

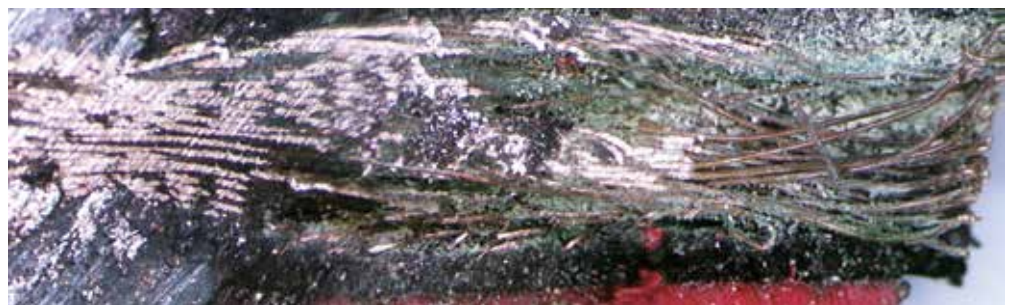
Fig 8: Section through the ring connector and the wire (ring on left of image). Green corrosion seen through wire showing wire coating has become compromised.

cable entry on the left of the photograph. In this, greenish and white compounds can be seen that appear to be affecting the individual copper strands of the cable bunch. Although not identified, the corrosion products may be cupric chloride, which is green, and lead chloride, which is white. These could be the result of a reaction between HCl released from the charred PVC coating and the lead and copper of the terminal and cable respectively.

create heat. Overheating of the wire insulation of the connector cable could assist in plasticiser migrating out of the PVC material leading to embrittlement. The insulation material would then crack and expose the copper and lead metals when subjected to the normal handling procedures of the formation process. This would conceivably allow sulfuric acid to penetrate the insulation material and corrode both the copper wires and lead where they are joined in the connector terminal. There would be a further increase in the resistance of the connector, adding to the already inefficient

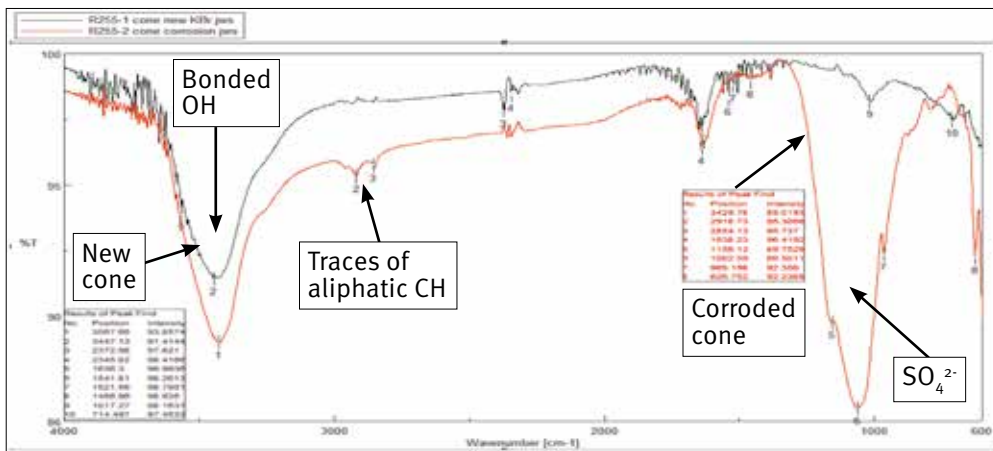
Fig 9 compares the FTIR spectra of scrapings taken from the new and corroded cones. In **Fig 10**, the open ring type connectors are analysed and this compares the FTIR spectra of scrapings taken from the new and corroded rings. Both show a large broad peak at about 3500cm^{-1} , which is normally indicative of hydrogen bonded hydroxyl (OH) groups. The main difference is the presence of a large broad peak centred at about 1060cm^{-1} that is related to the polyatomic sulfate (SO_4^{2-}) ion. The scrapings taken from the corroded cone also contain traces of aliphatic hydrocarbon species, suggesting that the PVC has lost some plasticiser materials. This bears out the previous conclusion relating to cable embrittlement and subsequent acid ingress to the

Figure 9. Overlay of FTIR spectra of scrapings from new and corroded cones

Both sets of connectors show major peaks for OH and SO_4^{2-} groups, which suggests that the lead terminals of the connectors have both lead hydroxide and lead sulfate on their surfaces. This is entirely consistent with the range of voltages and pH conditions which the connectors will be subjected to in normal use.

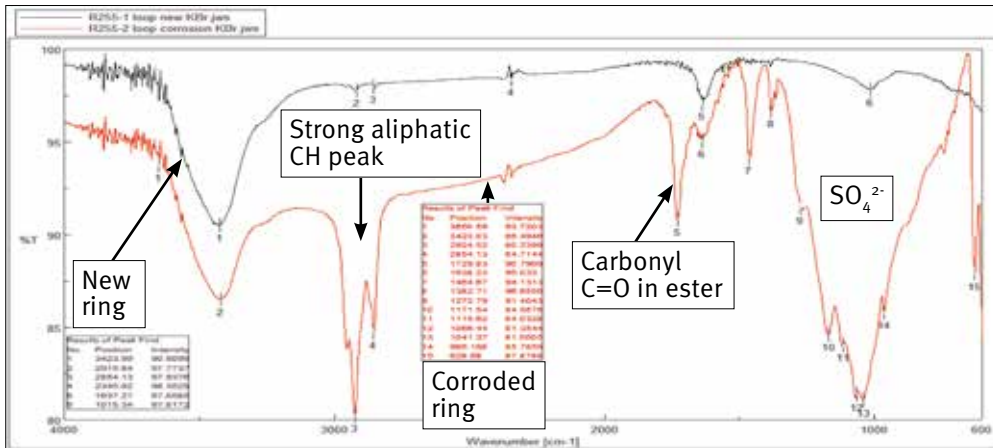
Figure 10. Overlay of FTIR spectra of scrapings from new and corroded rings

The organic molecules identified, ie. aliphatic CH and carbonyl C=O in ester groups, are present in both the used cone and ring connector samples. Again, as with the cone design of connector, the used ring scrapings show the presence of a large broad peak centred at about 1060cm^{-1} , that is related to the polyatomic sulfate ion (SO_4^{2-}), a strong aliphatic CH peak at about 2900cm^{-1} , together with a carbonyl (C=O) peak at about 1730cm^{-1} both of which point to release of plasticiser. The scrapings taken from the corroded ring also appear to show significant levels of an esterified aliphatic hydrocarbon species, suggesting that the used ring may have been exposed to high temperatures, resulting in the PVC losing significant plasticiser material.

Whilst there are some similarities in the positions of the peaks, there is a big difference in the peak amplitudes. These are most significant for the aliphatic CH and the carbonyl C=O in ester. The main conclusion to draw here is that the insulation breakdown of the connector cable is more severe in the ring
